# **Scotchkote 169 Pipeline Rehabilitation**

# Scotchkote

## Drinking Water Solutions

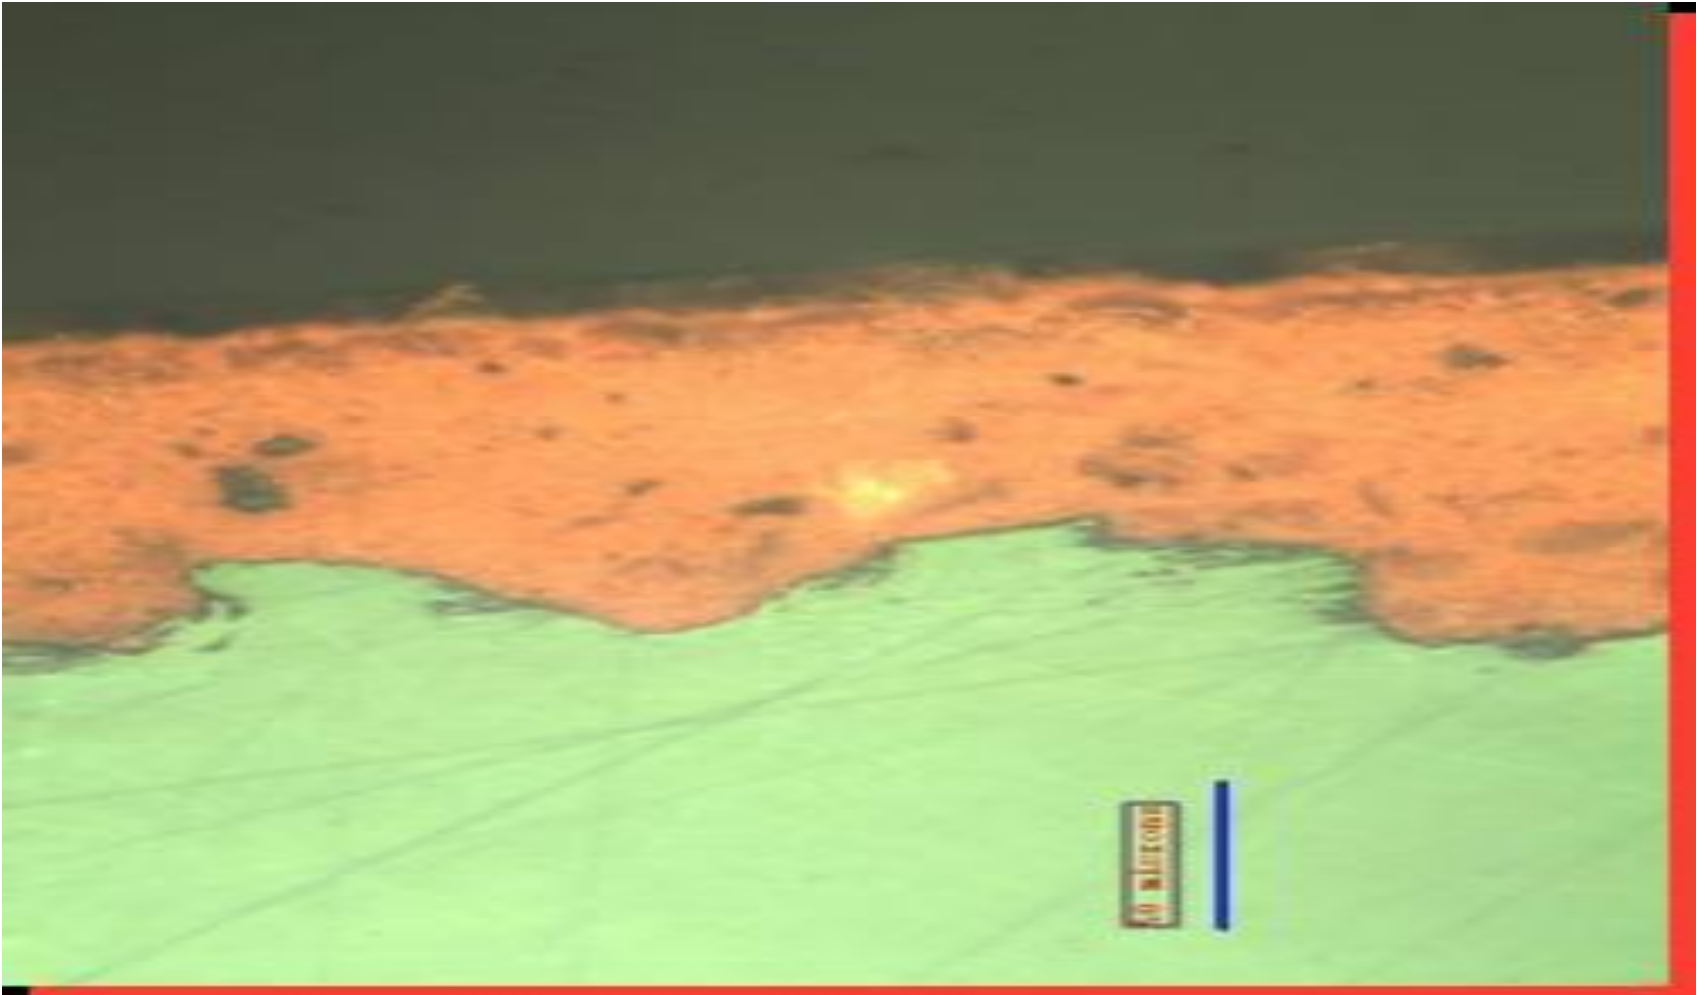
# Pipeline Profile Improvement

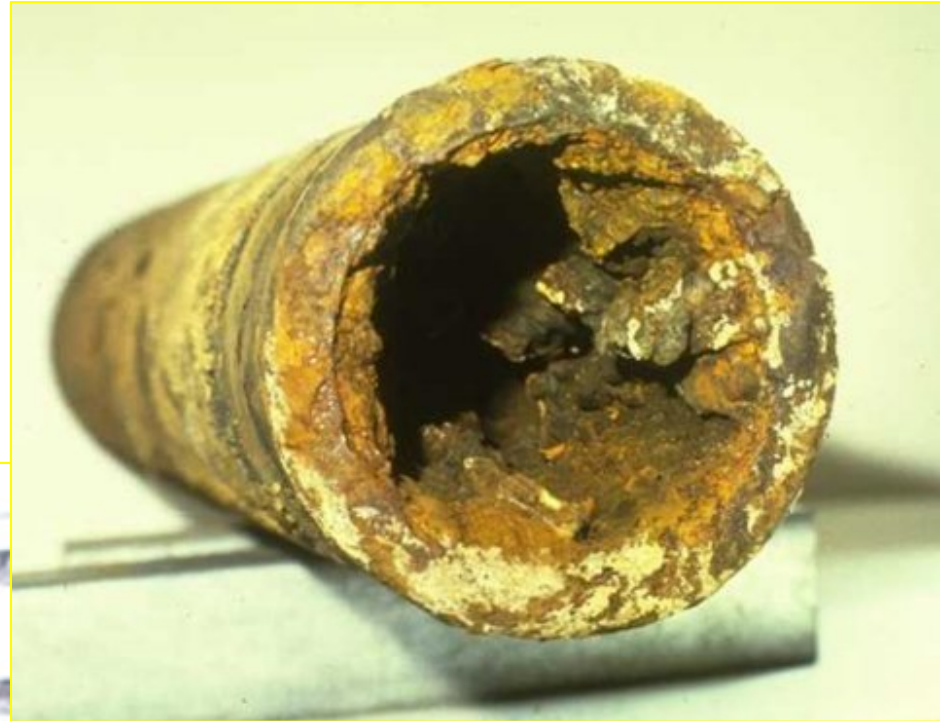
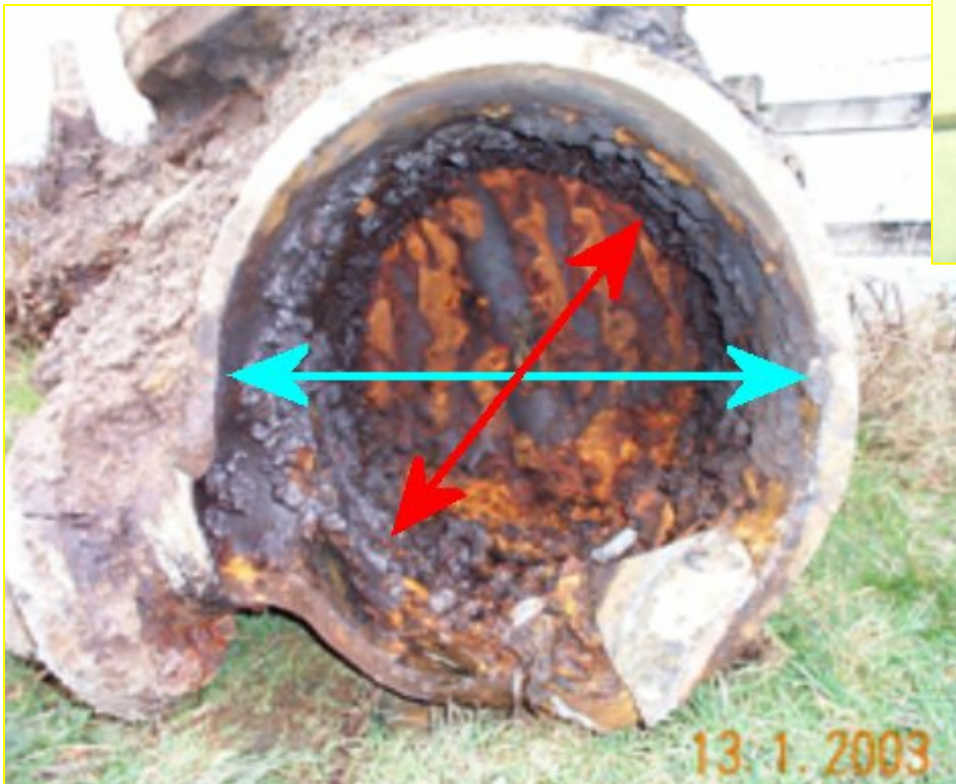
# Internal Deposits

To compound the problems these old pipes are often found to have cumulative deposits internally

- Water Quality
- Internal Diameter
- Water Flow
- Water Pressure

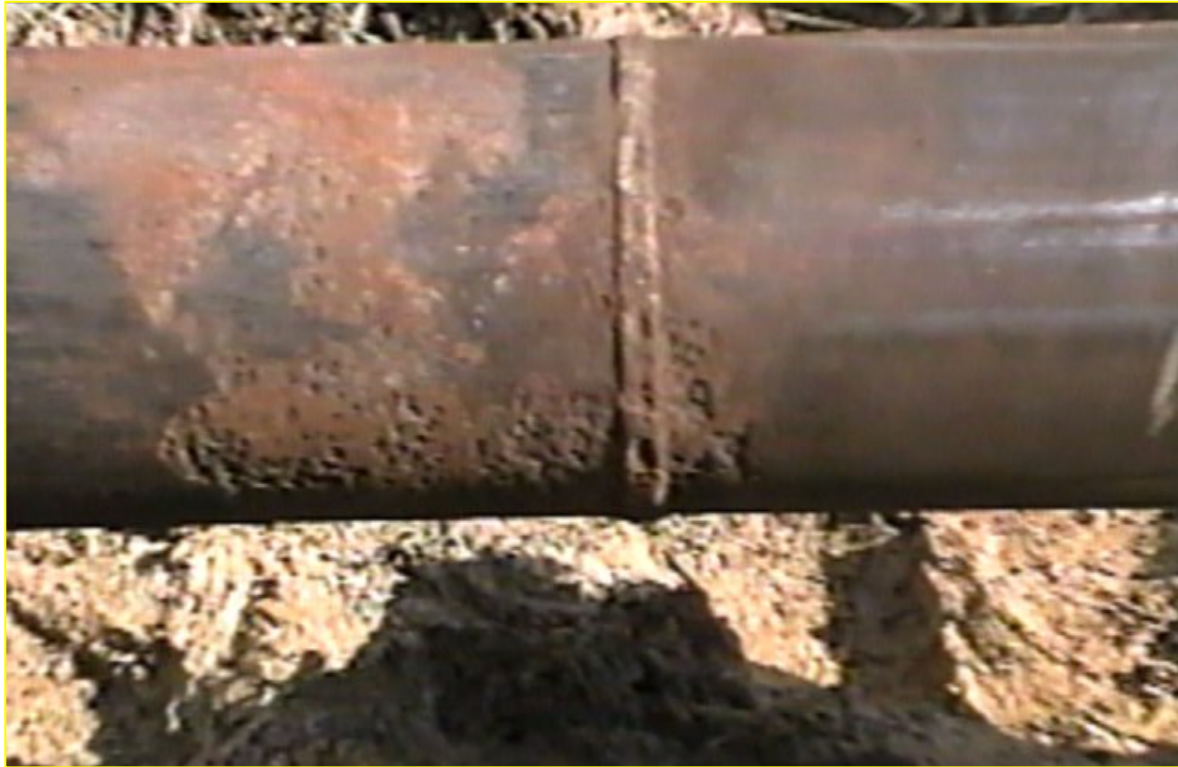
**Corrosion of iron mains  
may lead to...**

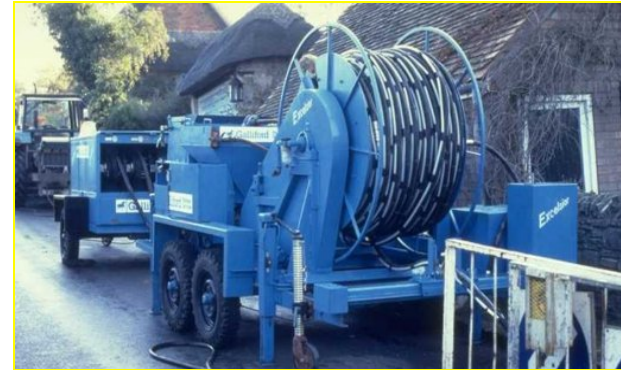
## Cement mortar used since 1930's

- A “**partially**” approved material because of water quality problems related to high pH and durability
- Dissolves in softer water
- Possible leaching of Al and other metals
- Applied at 4–6mm, reducing effective internal diameter
- Rough surface allows rapid internal tuberculations
- Slow Curing

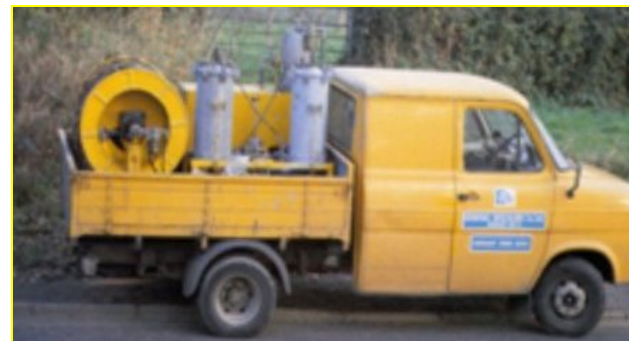
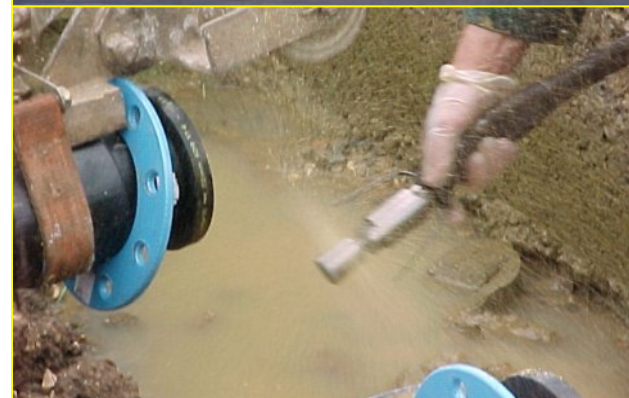
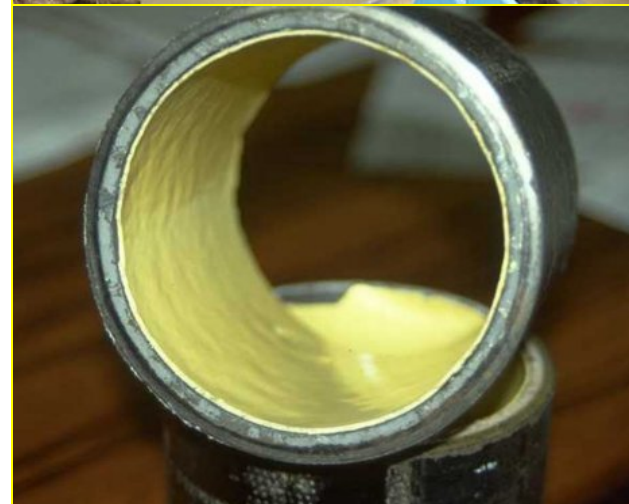
## Epoxy resins used since 1970's

- A major tool in most water utilities non structural lining rehabilitation project
- May be susceptible to blistering
- Slow Curing

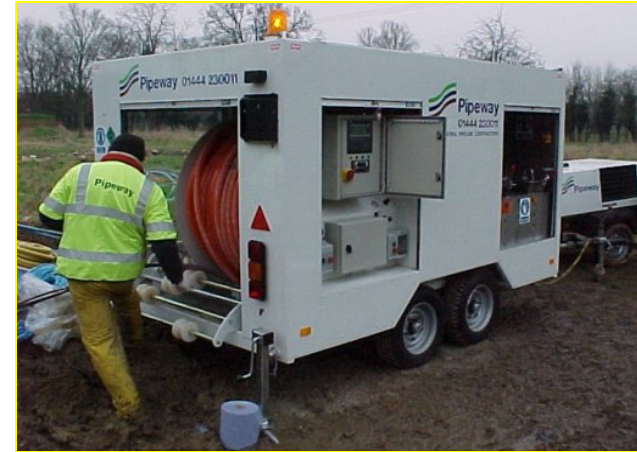
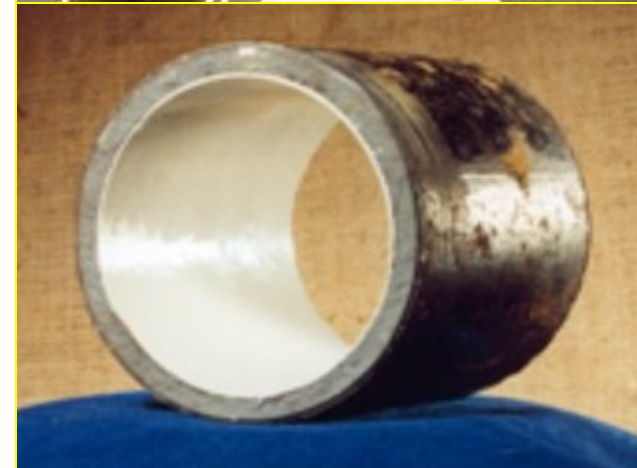
## Rapid-setting lining introduced 1999

- Fully approved
- More tolerant of adverse conditions
- Immediate inspection
- Rapid return to service
- Superior performance & durability
- Structural grades possible

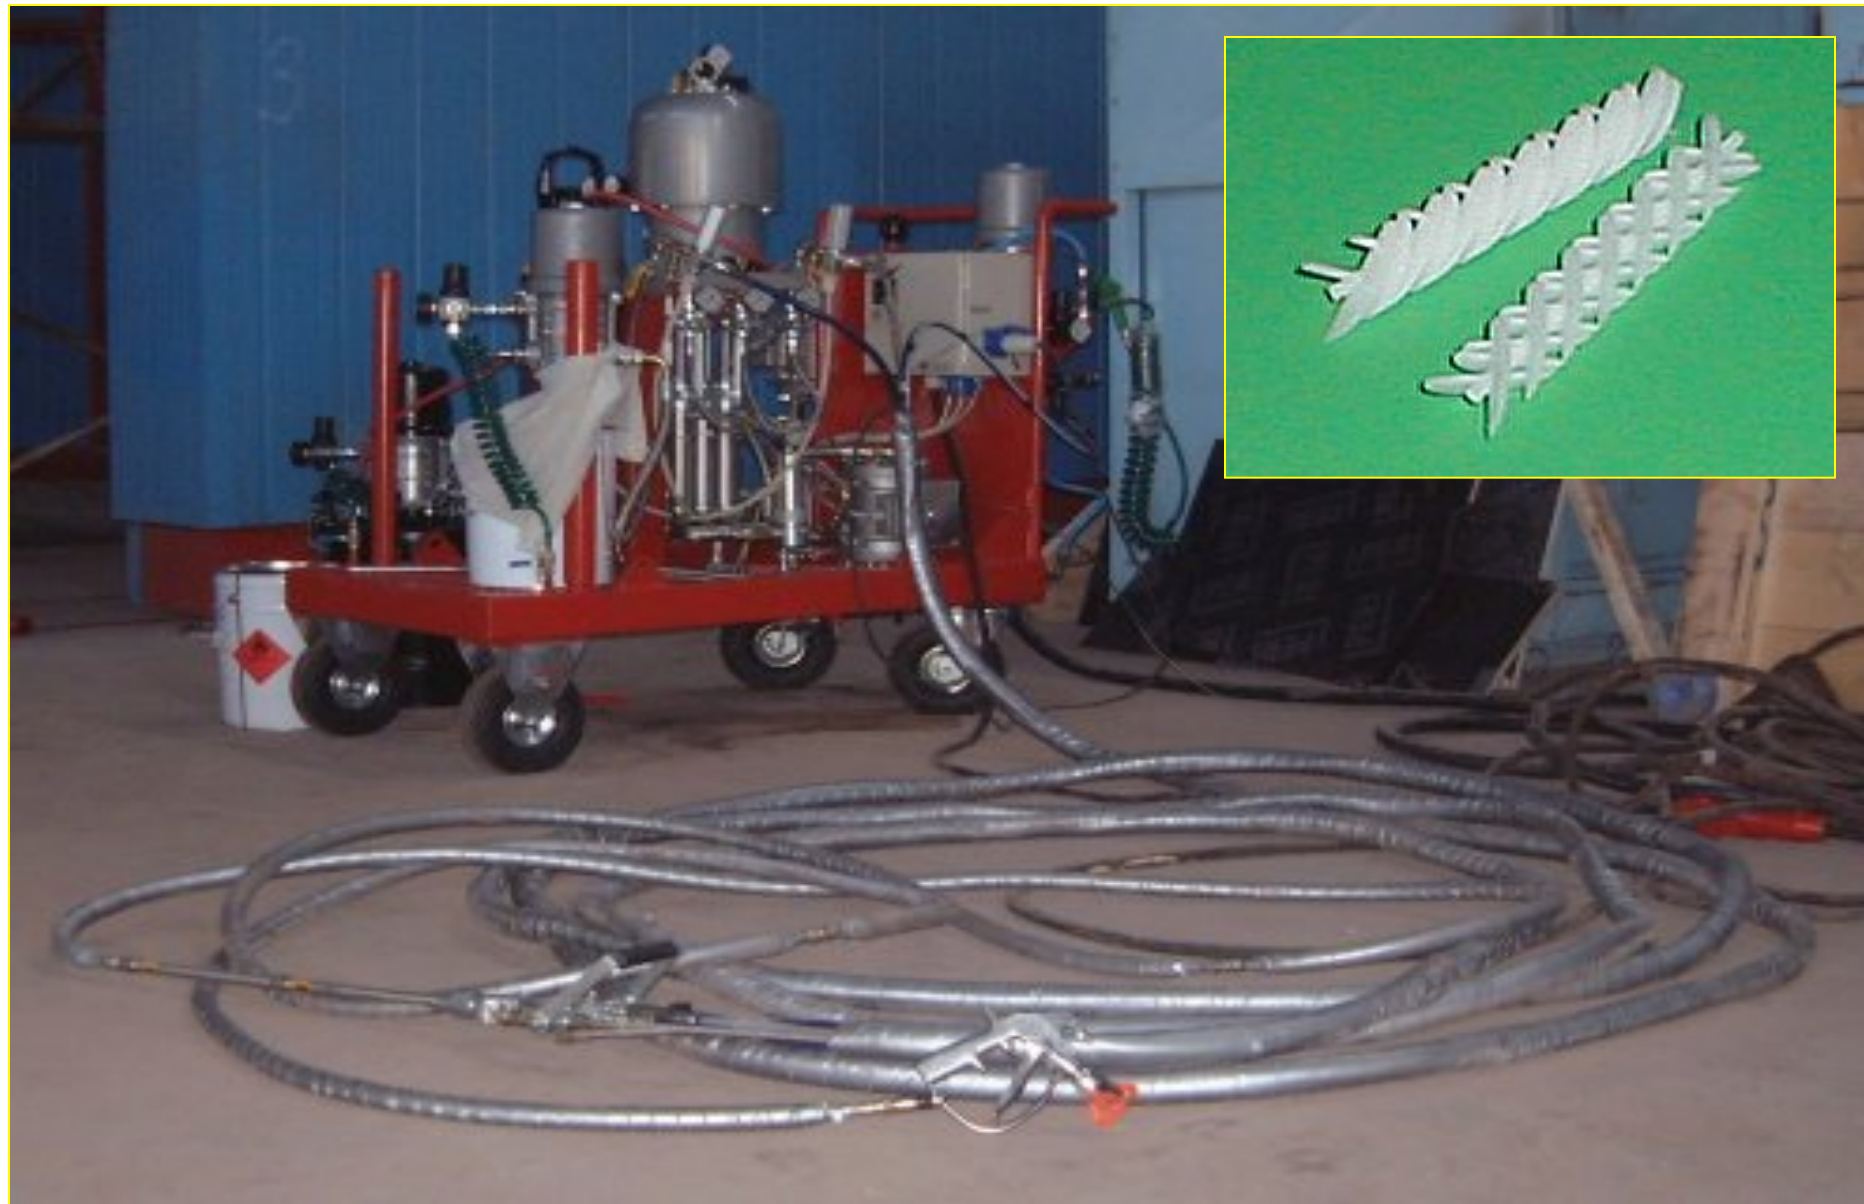
# Plural Feed Unit

## **An introduction to the Plural Feed Unit**

- These units are used to spray...
  - 2 Pack materials that have a short “Usable Life” or
  - 2 Pack materials that are too viscous to spray at ambient temperatures.

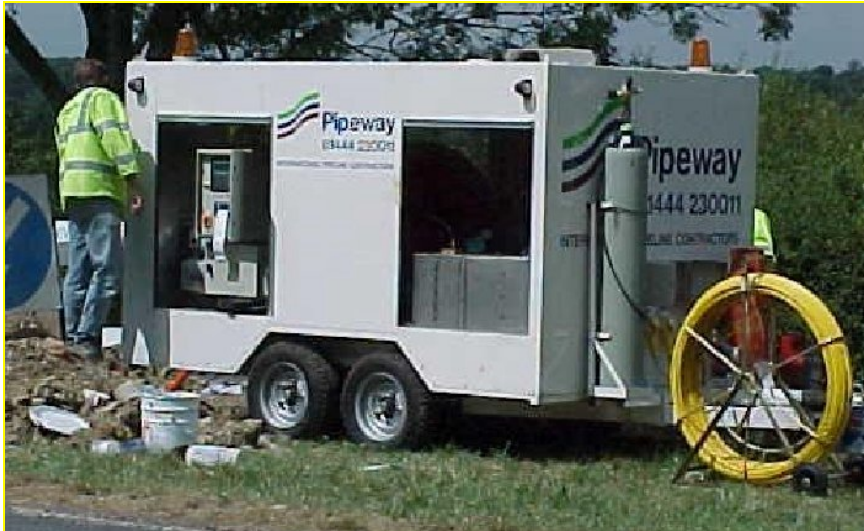
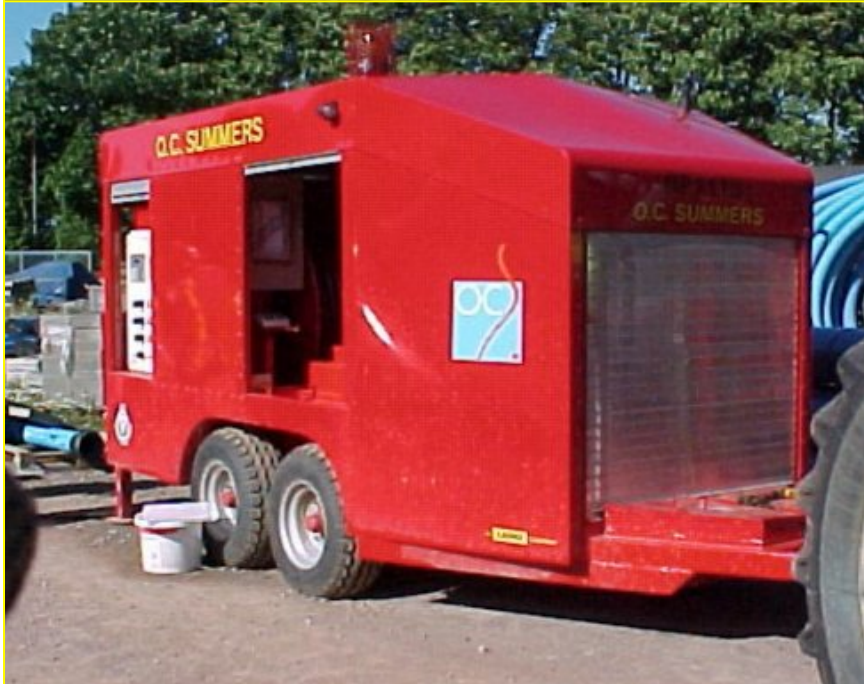
# The Lining Rig

The Plural Feed concept is used inside the application units employed in Insitu Relining Programs

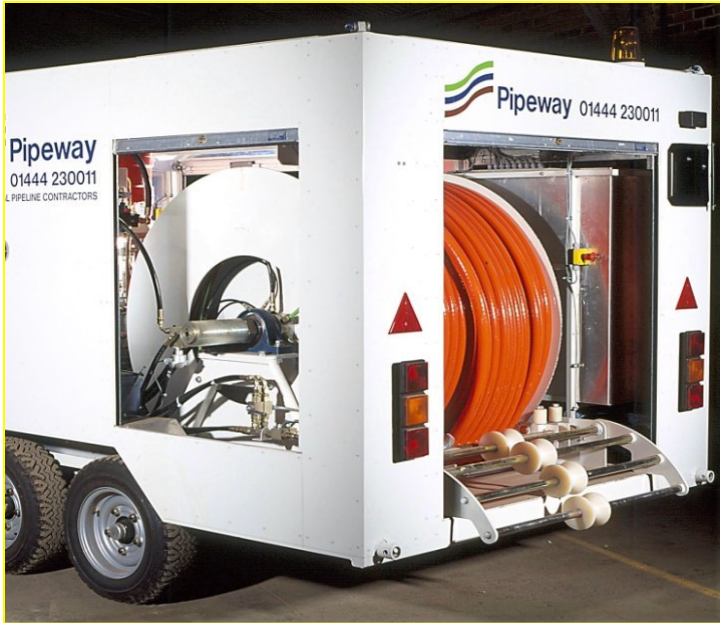
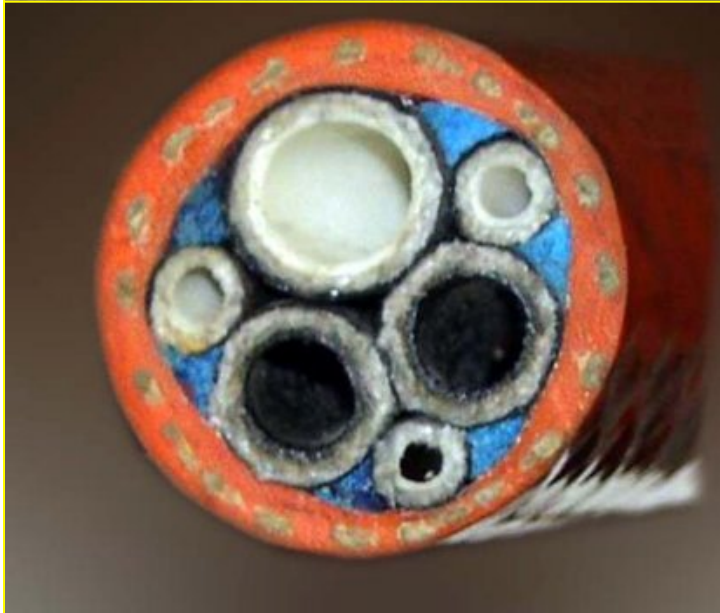
# Umbilical Hose

- The Umbilical hose is wrapped around a rotating drum & combines
  - Base Line
  - Activator Line
  - Air Line
  - Heating Line
- Hose Length = 220-300m
- Ext. hose diameter = >47mm
- The heated materials are pumped down separate tubes of the Umbilical Hose

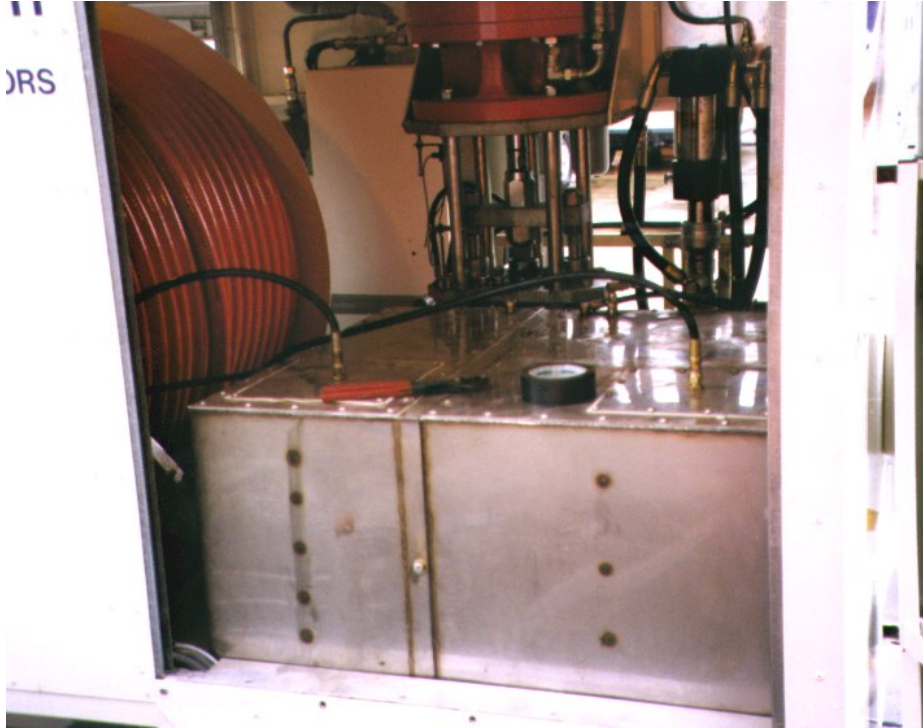
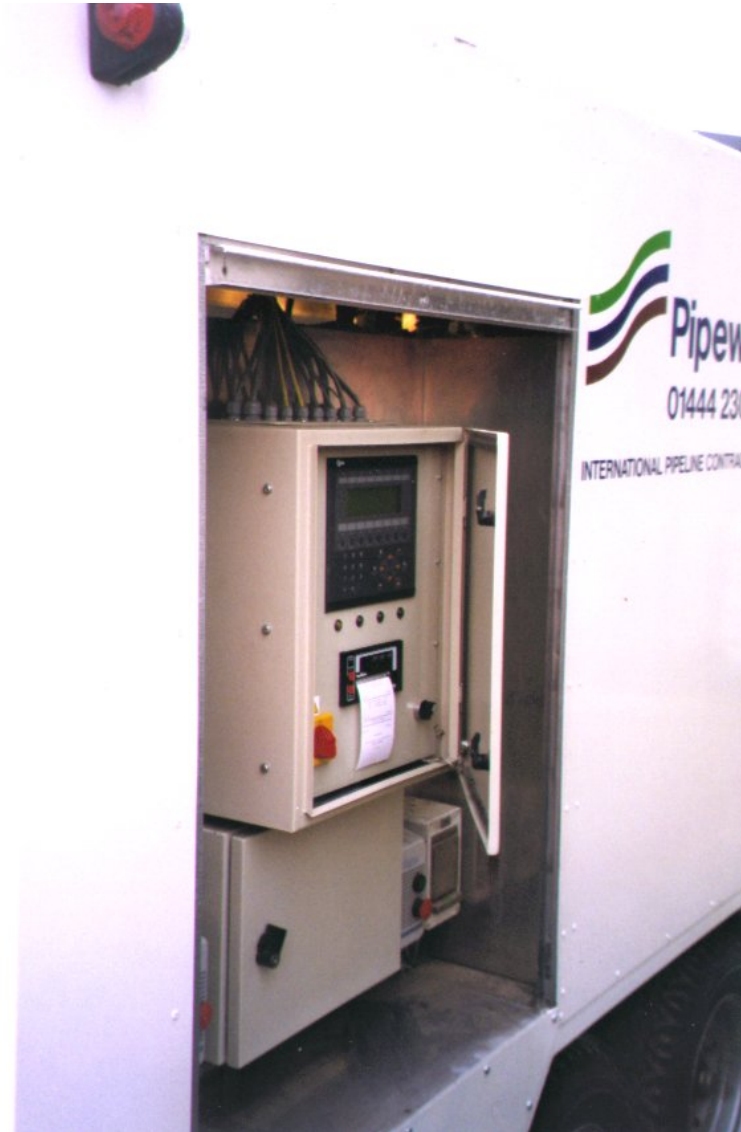
# Metering

- Metering ensures correct mixing of product at the head, no pot life problems

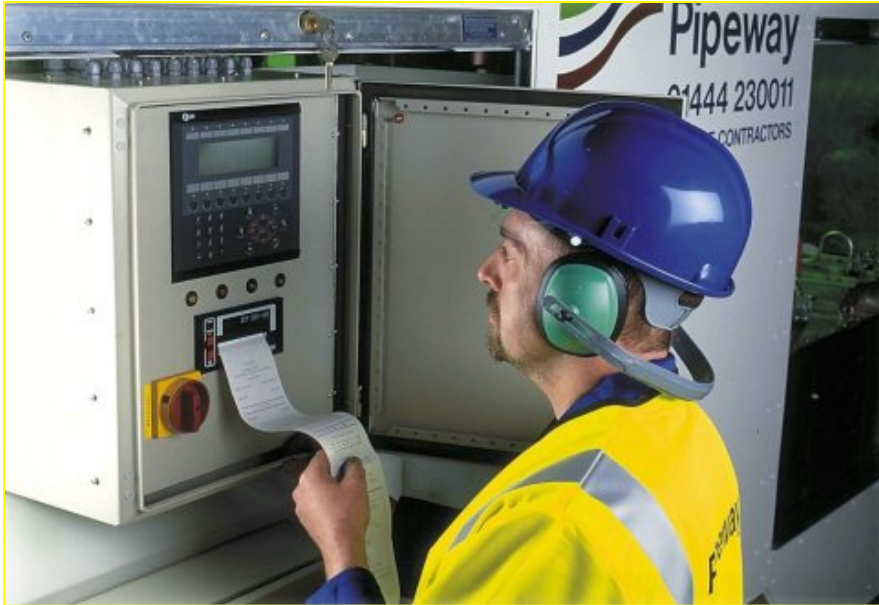
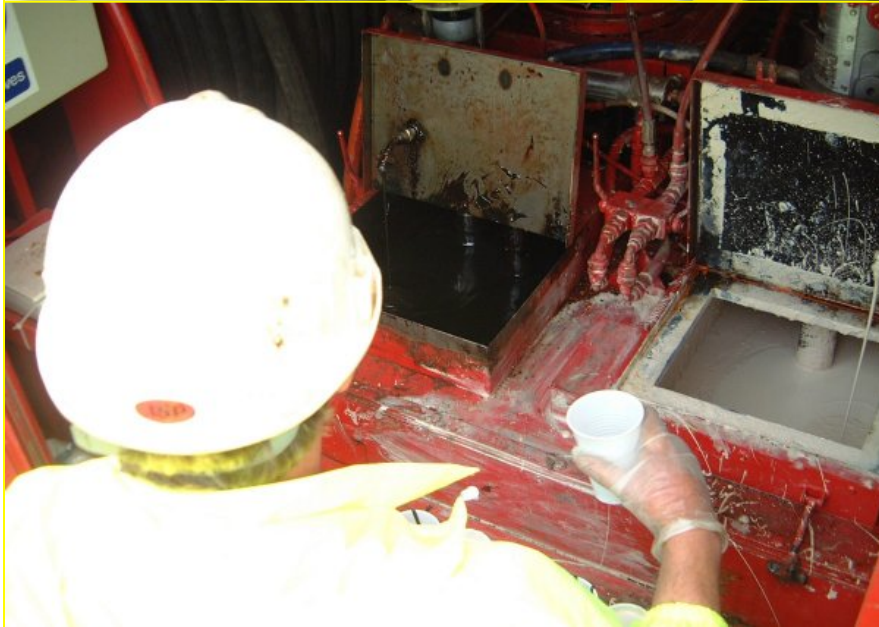
# Control

- Automatic Metering
- Computer Monitored Application
  - Working Pressure
  - Mixing Ratio
  - Flow Rate
  - Applied DFT
- Automatic Shut Down if “Off Ratio” ( $\pm 5\%$ )
- Security access codes

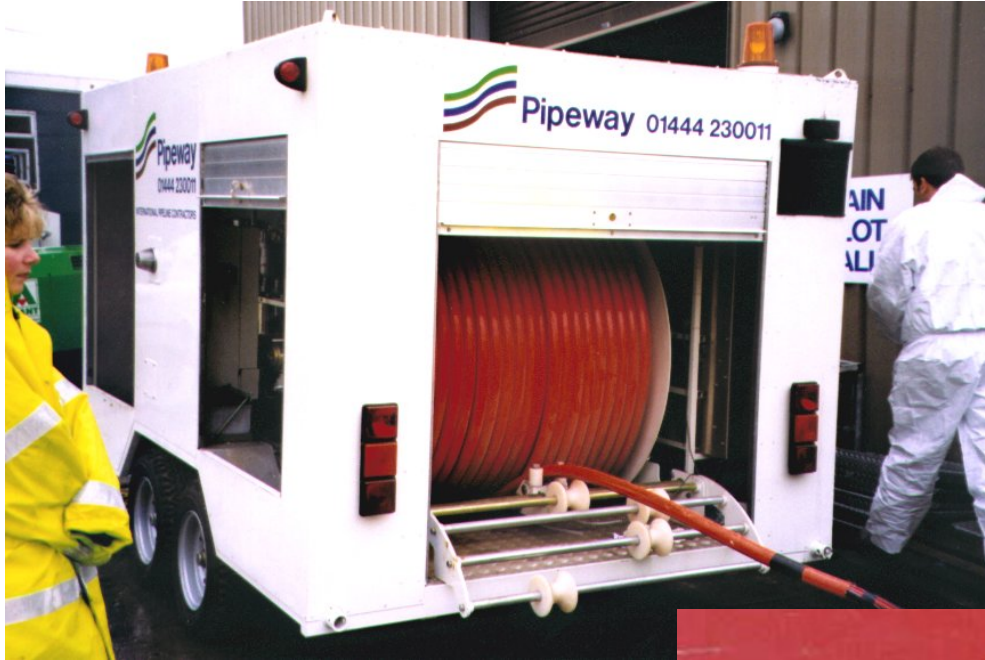
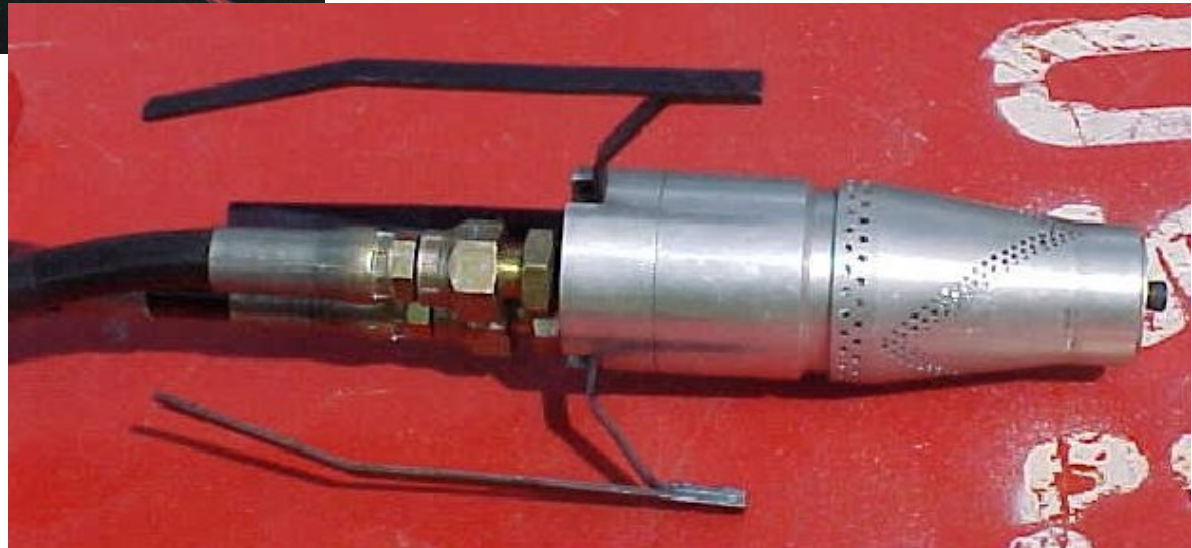
# Hoses & Spray Nozzle

Base and Activator materials are forced through a Static Mixer  
Applied by Spinning Head (25,000 rpm)

- Designed for optimum spray efficiency

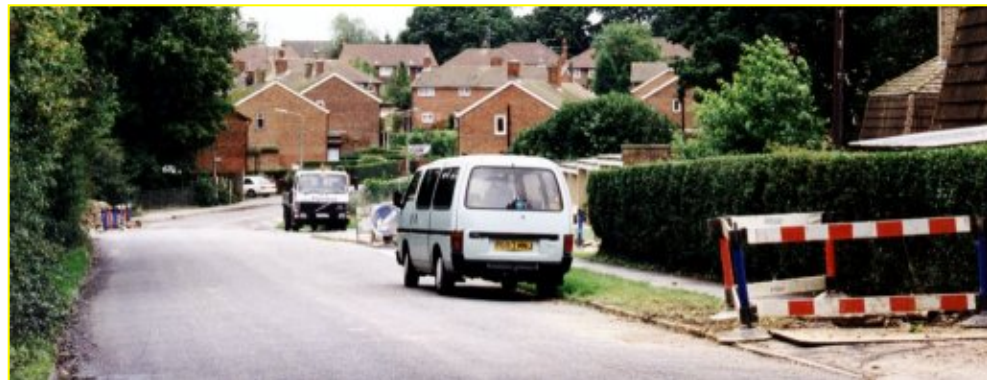
## • Preparation

- Notify consumers of works
- Isolate lining section
- Excavate access pits
- Remove fittings - bends, tees, valves

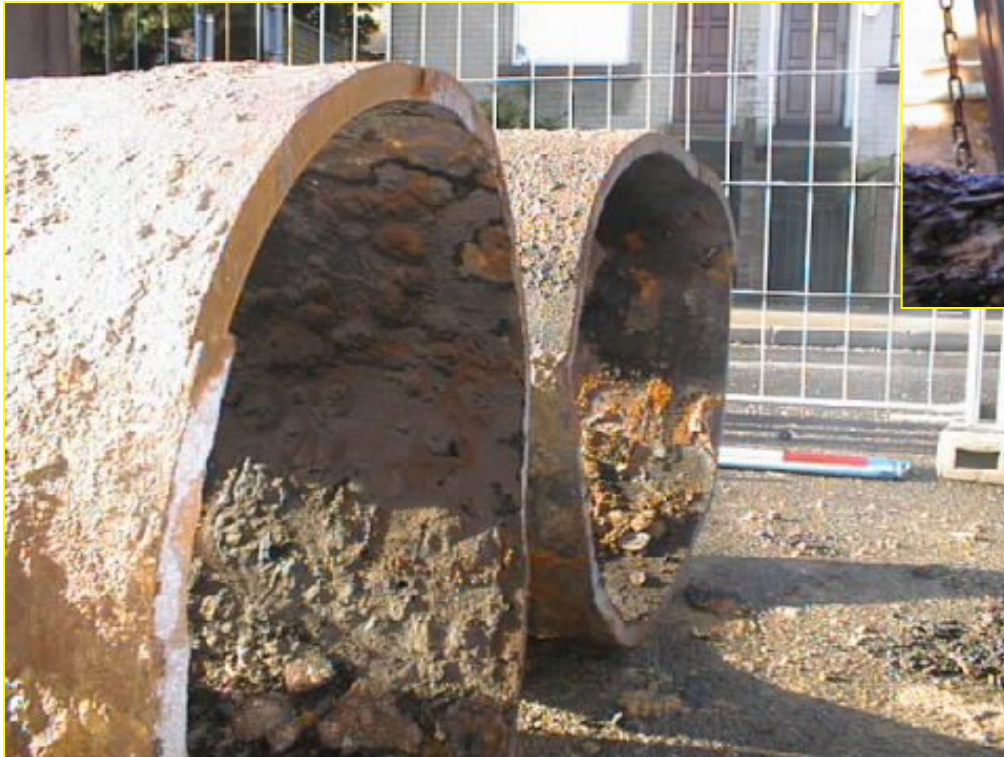
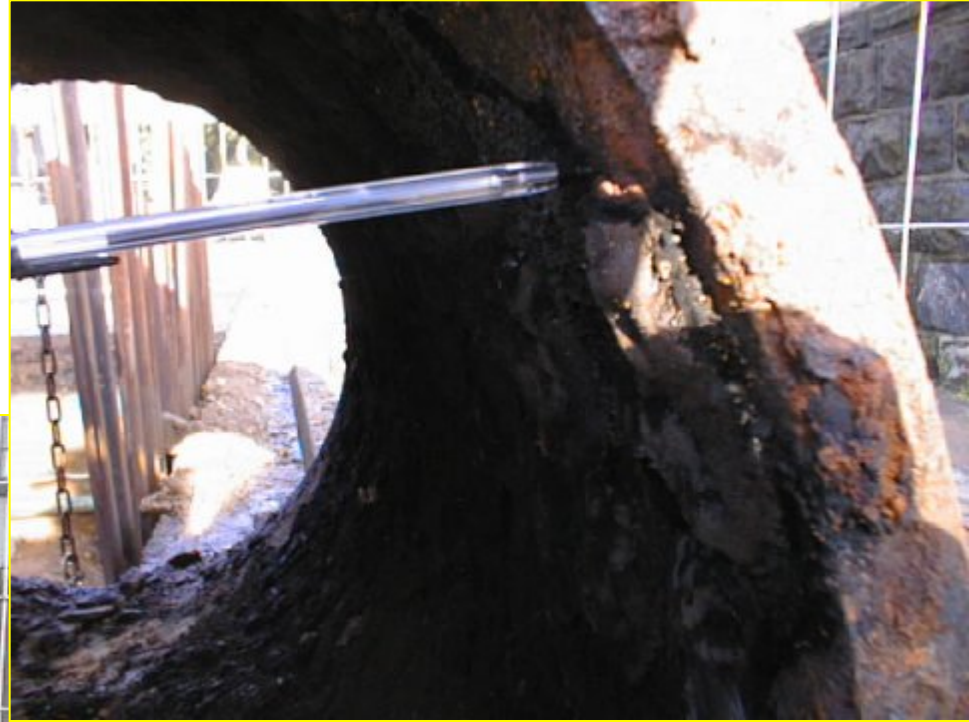
- **Oughtibridge,**  
Sheffield
- Drinking Water Main

- 5Km x 33"
- 2001
- Contracted to  
Pipeway

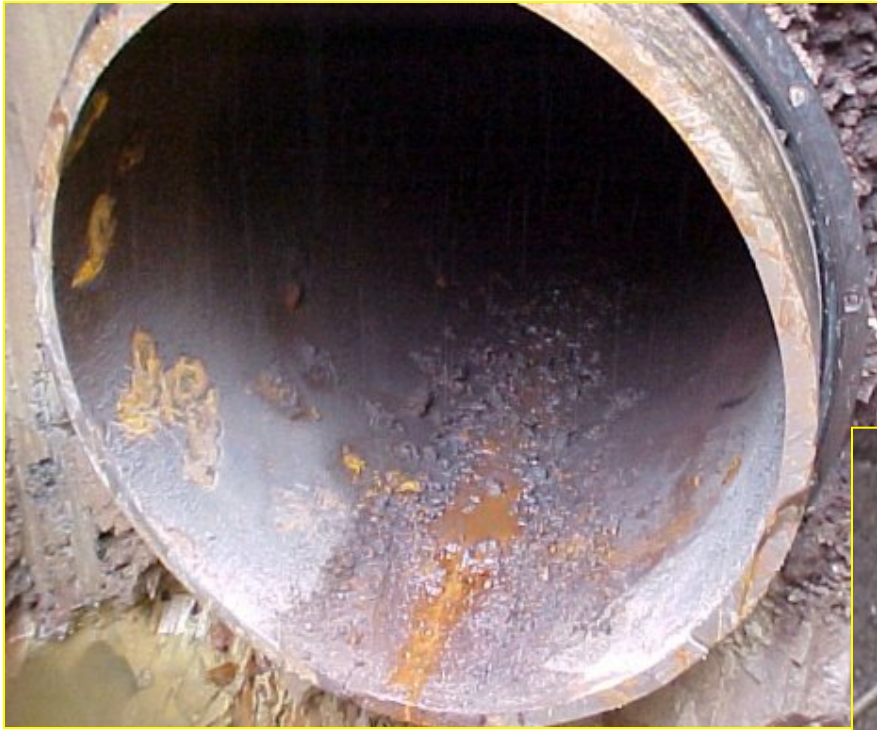
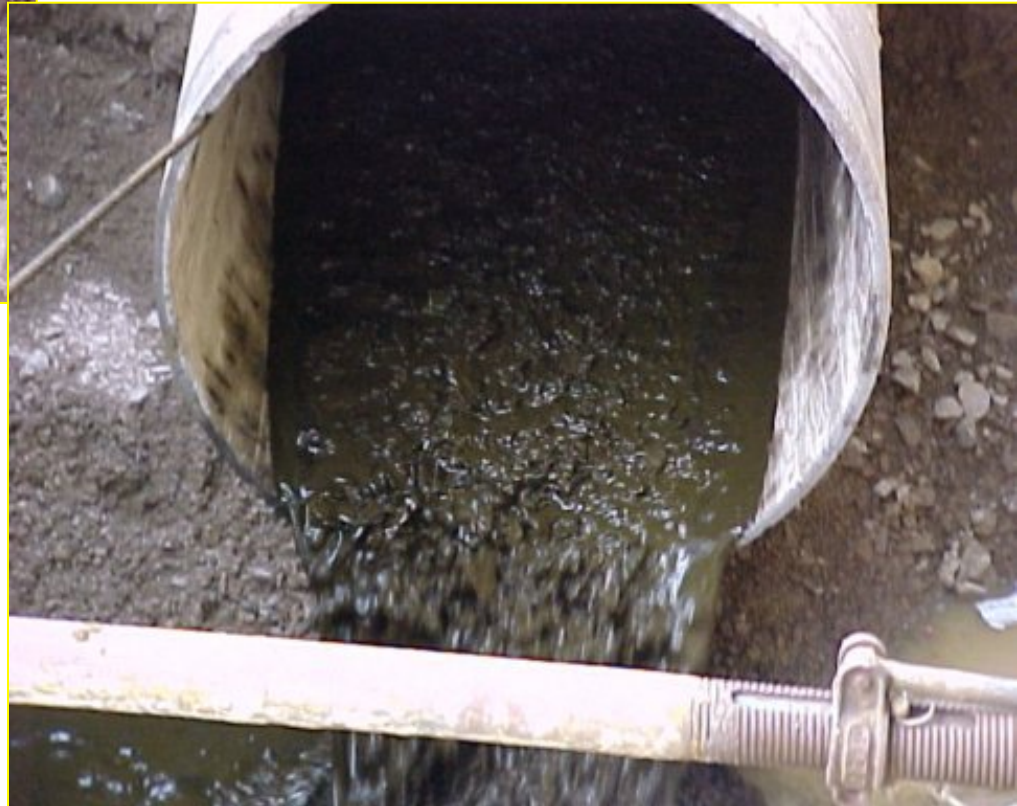
- **Crownhill, Plymouth**
- **Drinking Water Trunk Main**

- **36" Cast Iron**
- **2002**

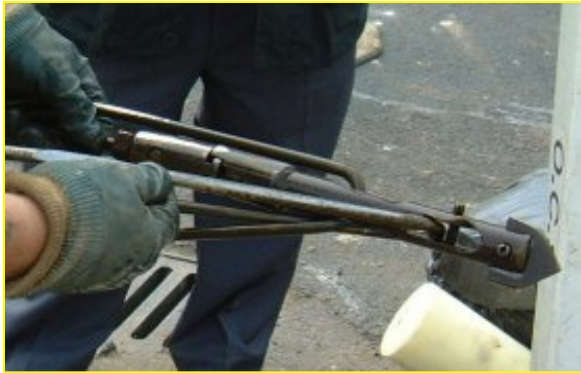
- **Swabbing**

- Foam Swab is propelled down the pipe using compressed air to remove standing water (normally 3 times)

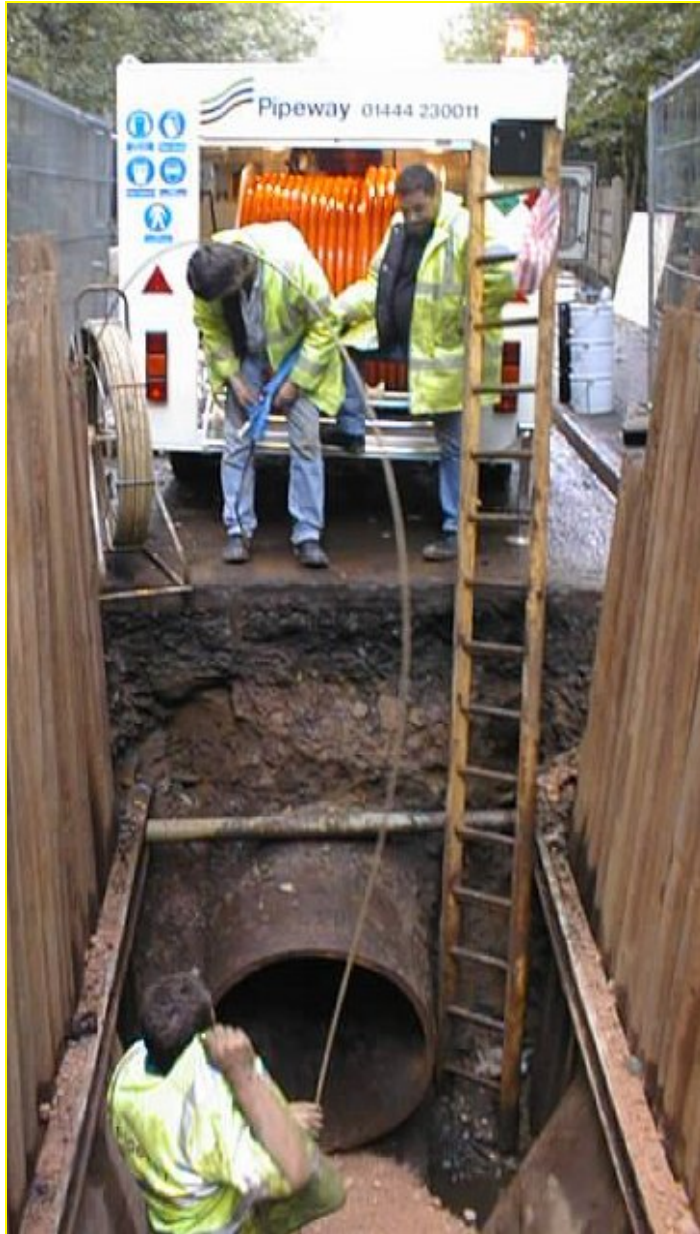
# Cleaning Stages

- **Pre-Lining Inspection**
  - CCTV camera is pushed down the pipe to inspect cleanliness

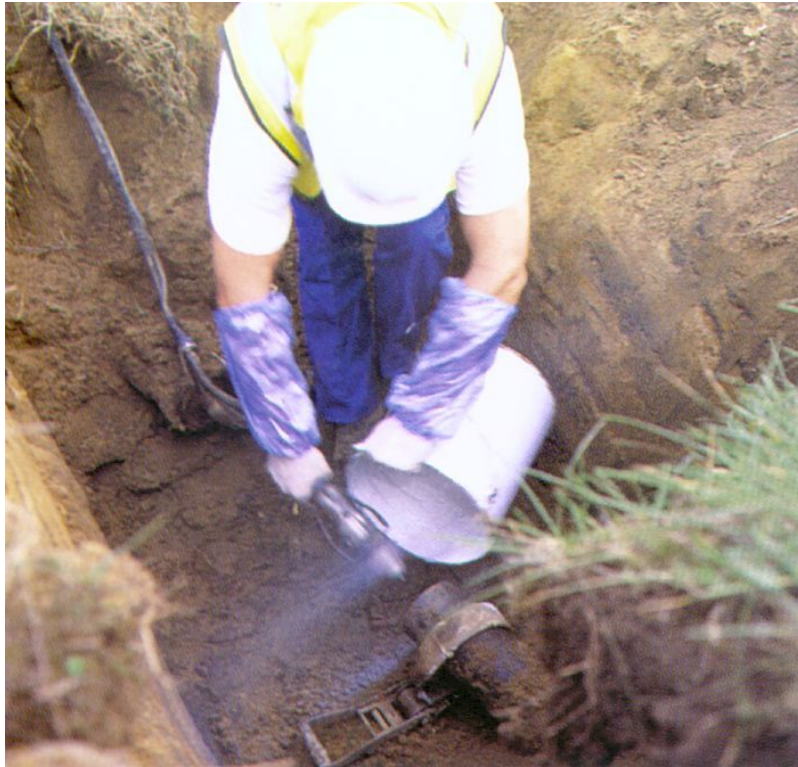
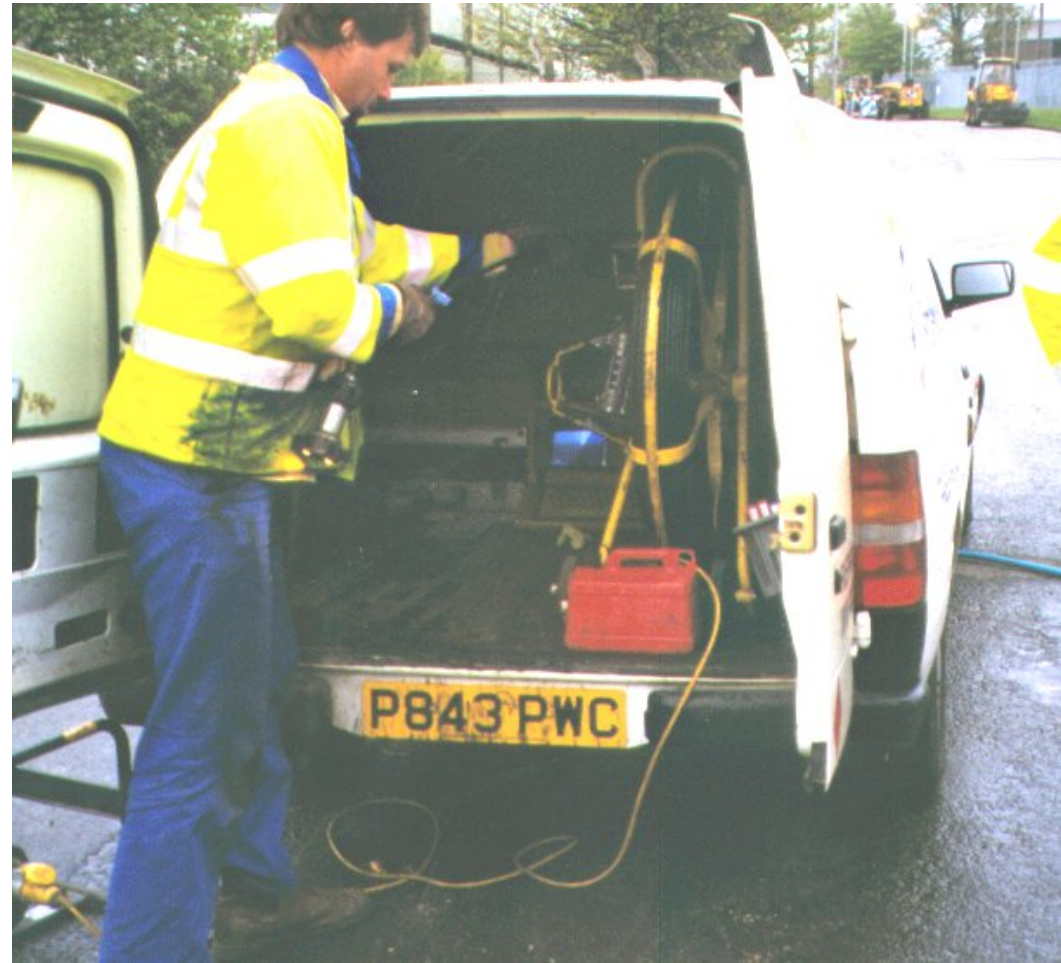
- Only need to expose pipe at 150 metre intervals

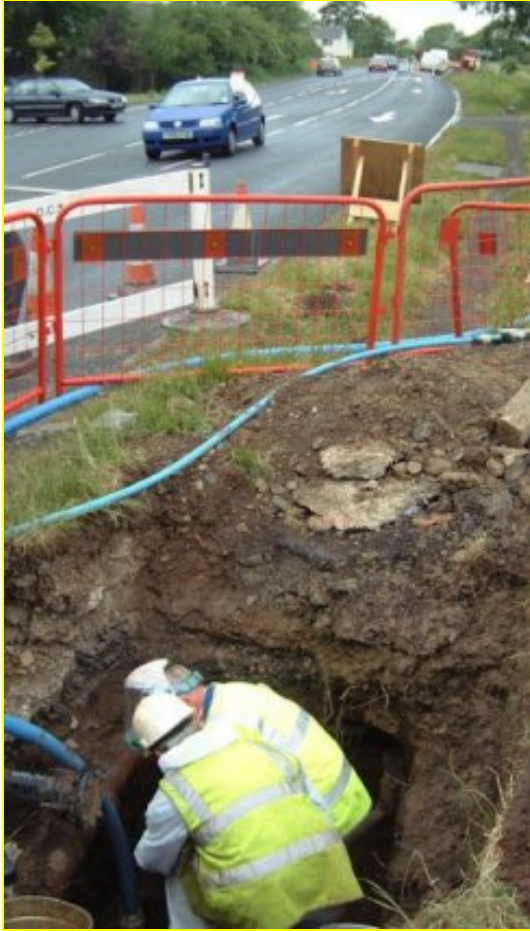
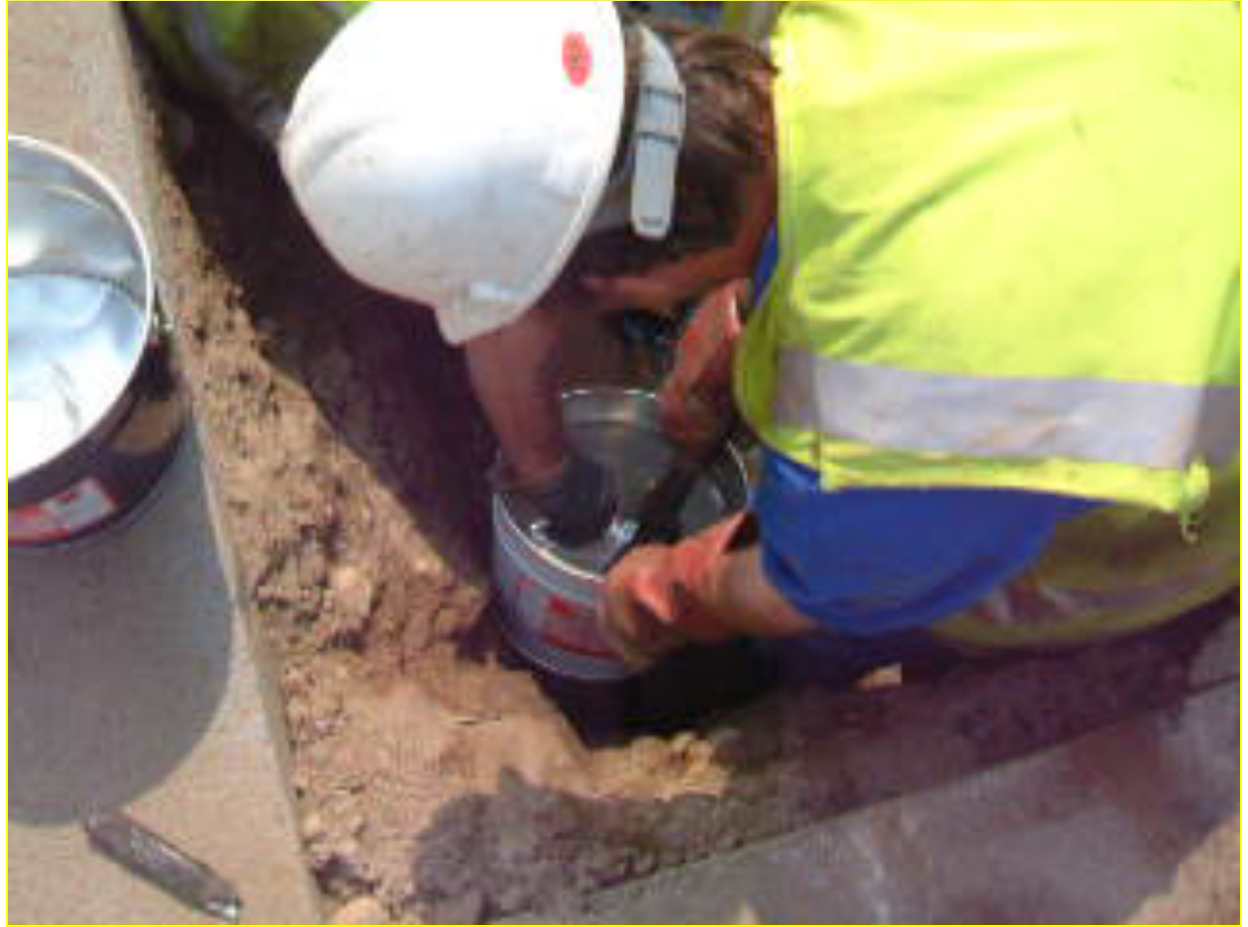
# Application

- Spinning head is pulled back and material is “applied on return”
- Lining thickness is determined by winch speed & material flow rate
