# **Scotchkote 169 Pipeline Rehabilitation**

# Scotchkote

## Drinking Water Solutions

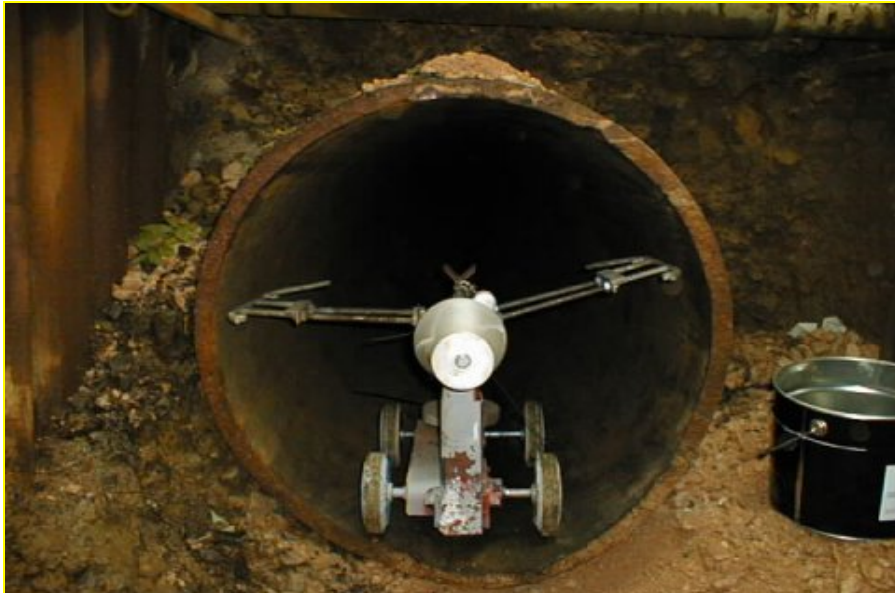
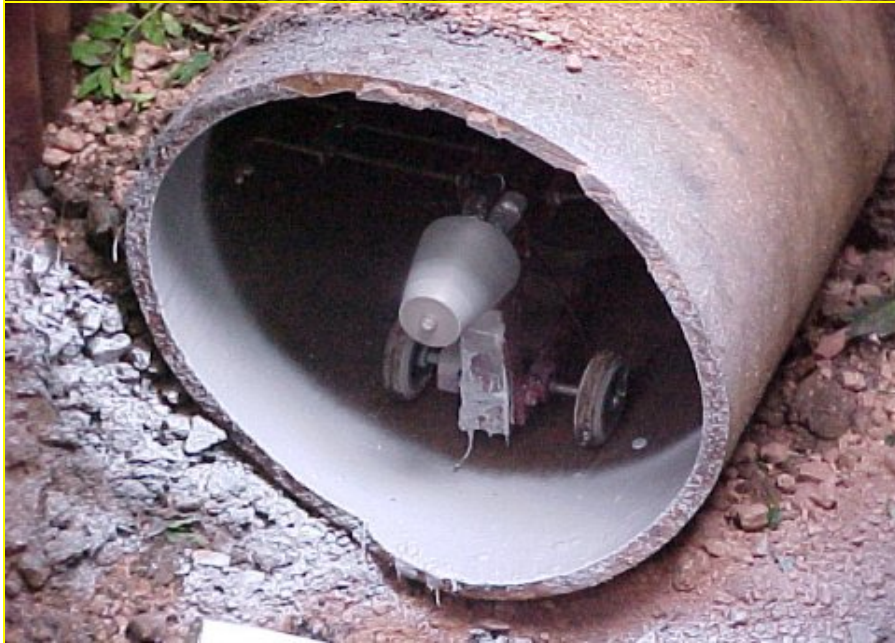
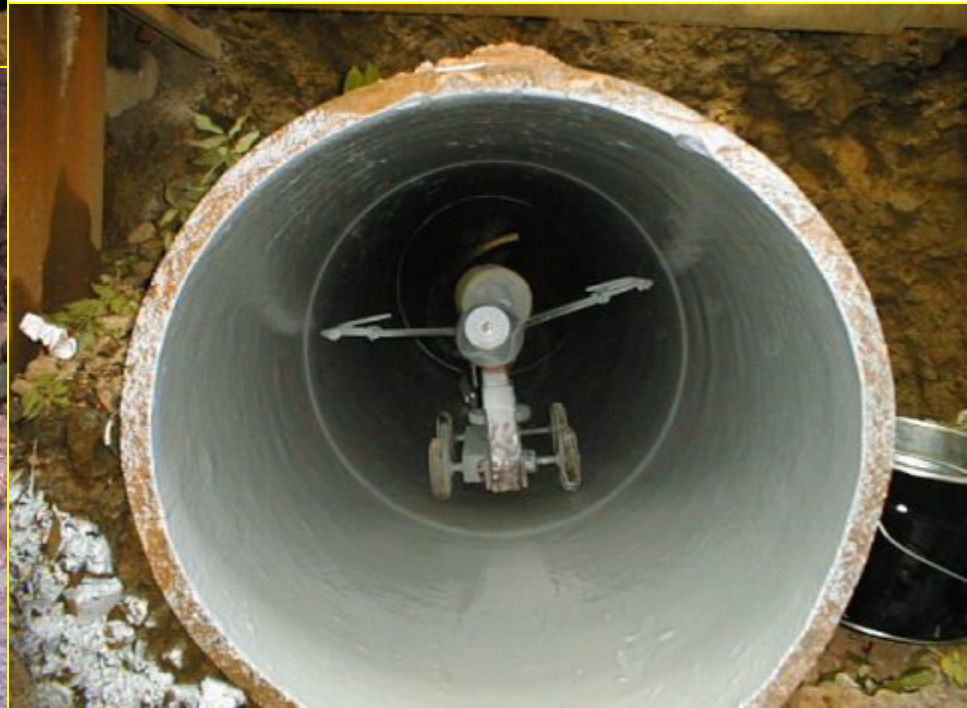
- Scotchkote 169
- 1.5mm DFT

- Spinning head is pulled back and material is “applied on return”
- Lining thickness is determined by winch speed & material flow rate

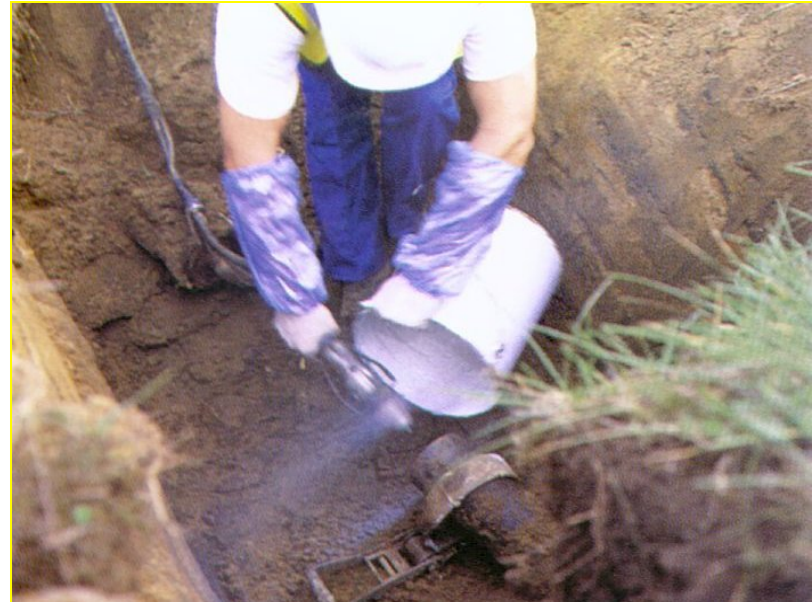
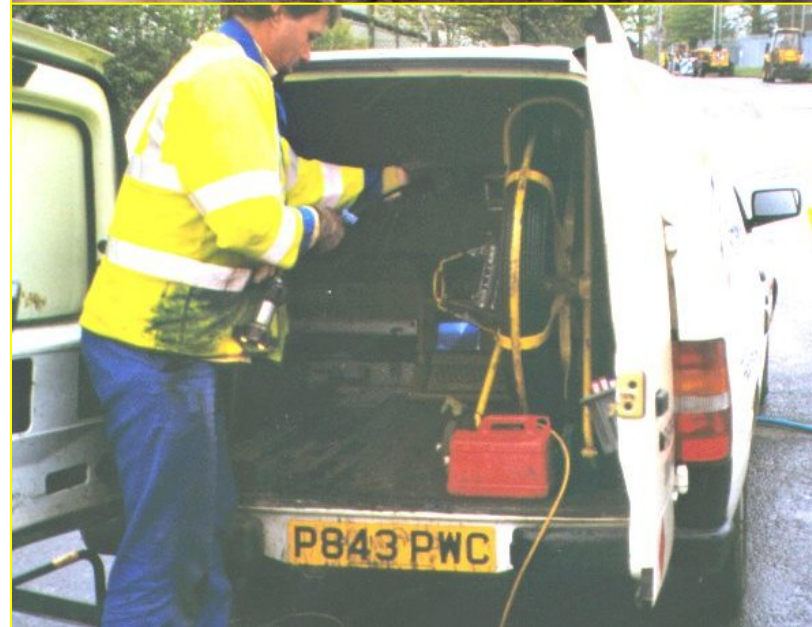
# Post Lining Stages

- Once spinning head has exited pipe, cap end & allow lining to cure
- Inspect lining with CCTV
- Reconnect & take cut-outs if required
- Disinfect & check residual chlorine
- Flush with drinking water
- Return main & customers to service
- Sample water for bacterial examination

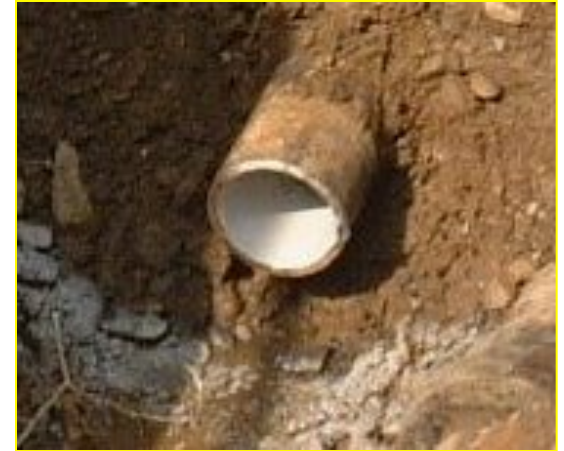
- **Skotchkote 169**

- Solvent Free Urethane
- Typical DFT = 1mm (up to 6mm)
- Curing to handle = inside minutes @25°C
- Return to Service = 30 minutes @7°C

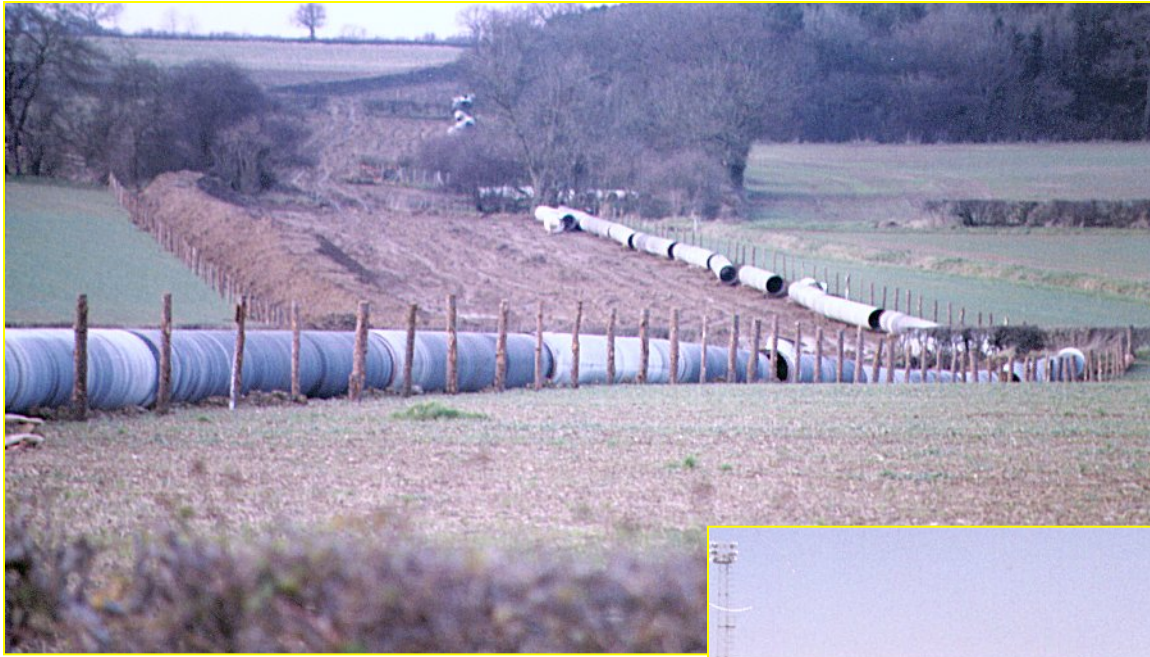
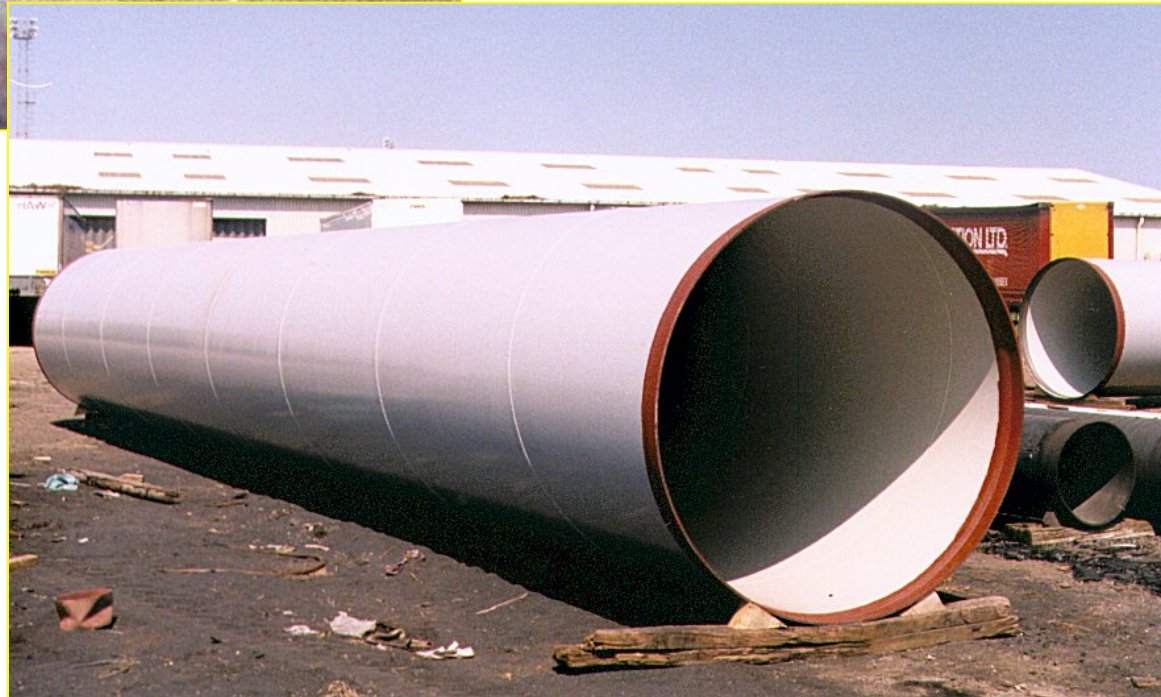
Anglian Water  
Trunk Main

Scotchkote 169

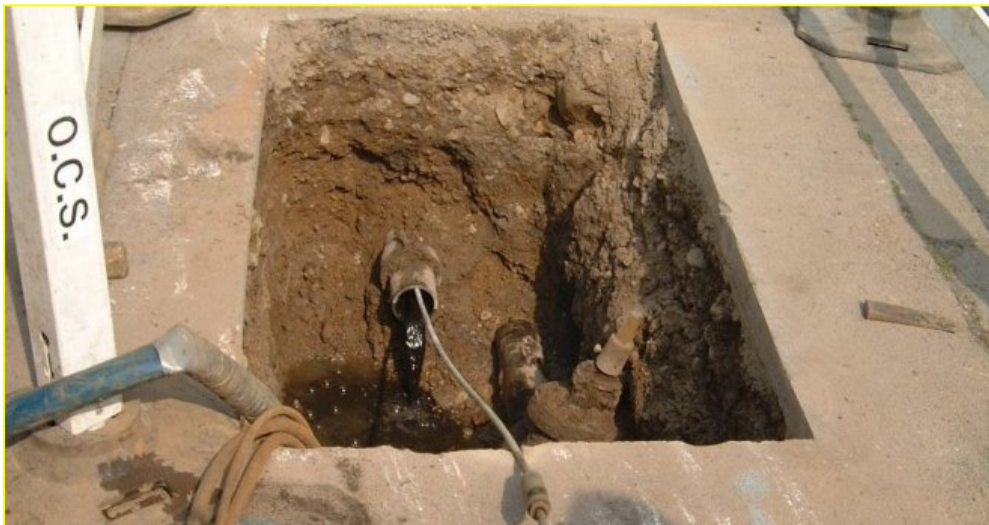
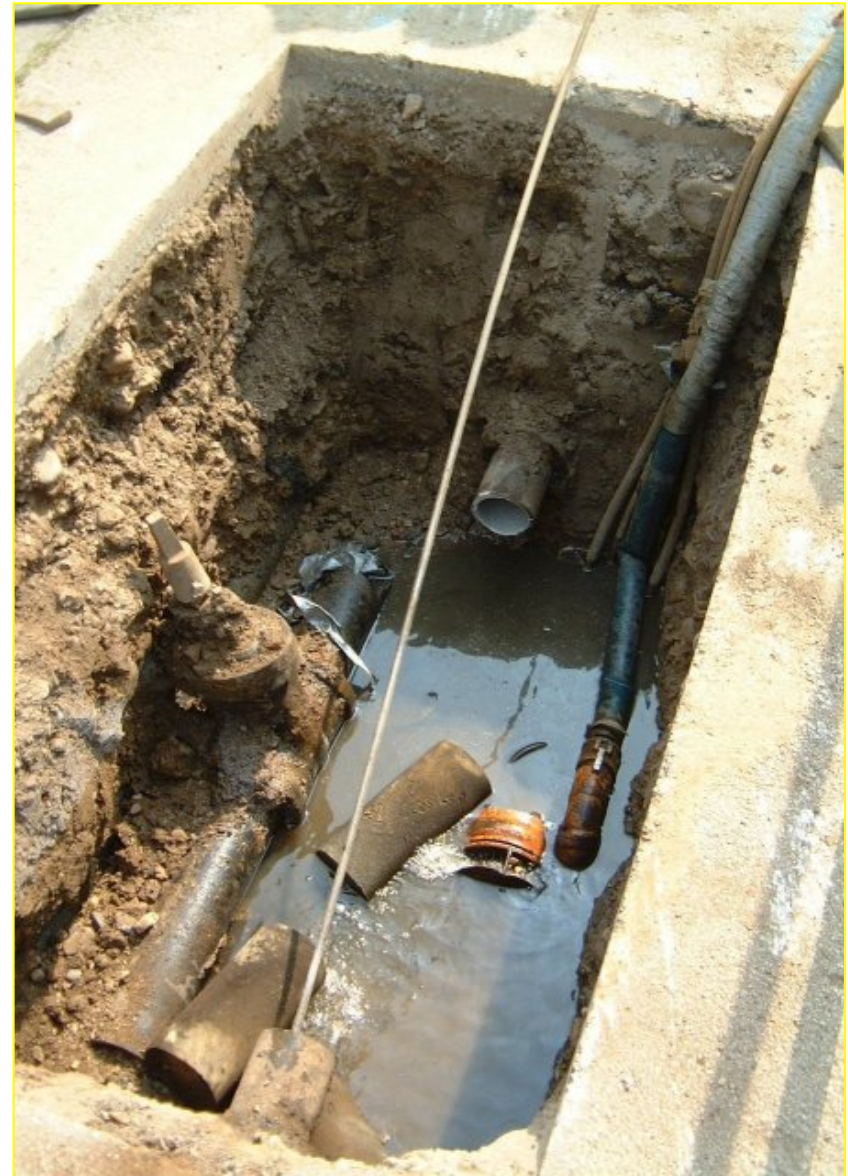
- **Ripon**
- Urban Drinking Water Supplies
- 3" - 6"
- 2001 - 2002
- By Laing Utilities
- Scotchkote 169 (1mmDFT)

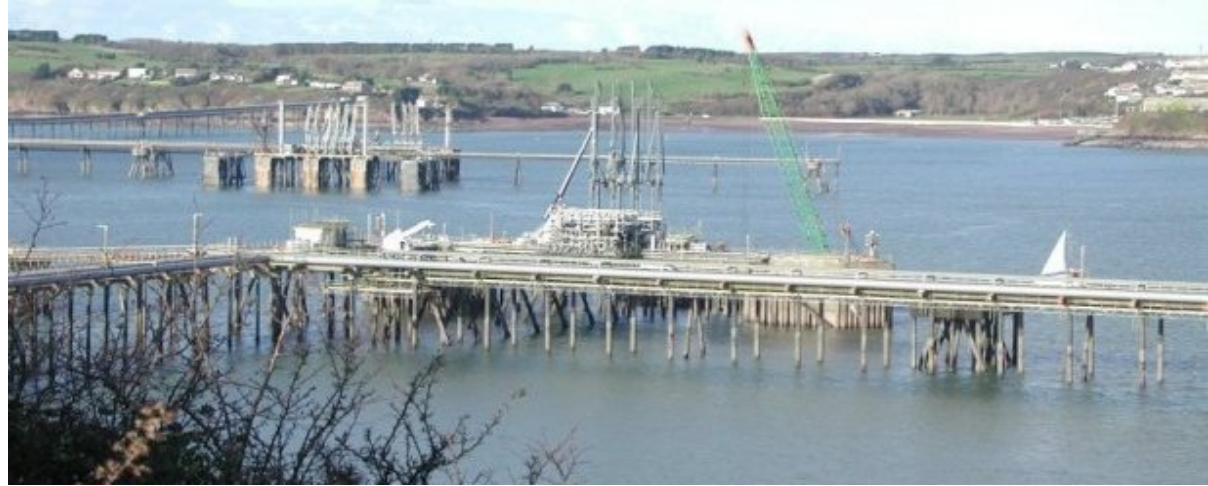
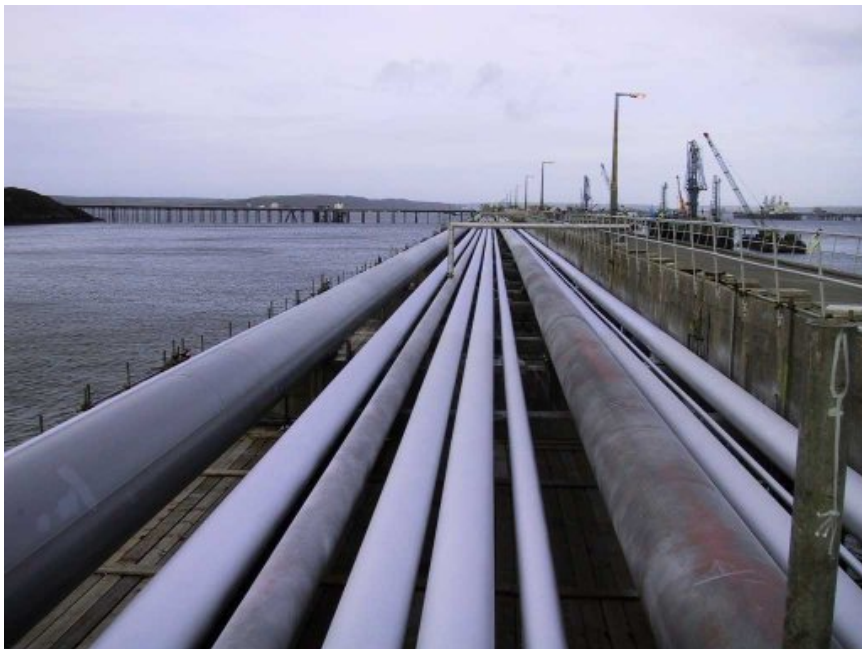
# Texaco Jetty- Pembroke Docks

- Rack Bored &
- Plunged
- Prepared St2

- **Scotchkote 175 HB**
- 2mm DFT
- 180m lengths
- By Pipeway
